# FE295 WIRE DRAG

## DESCRIPTIVE REPORT

Type of Survey .. Wire Drag .....

Sublocality ..... Approaches to Aransas Pass .....

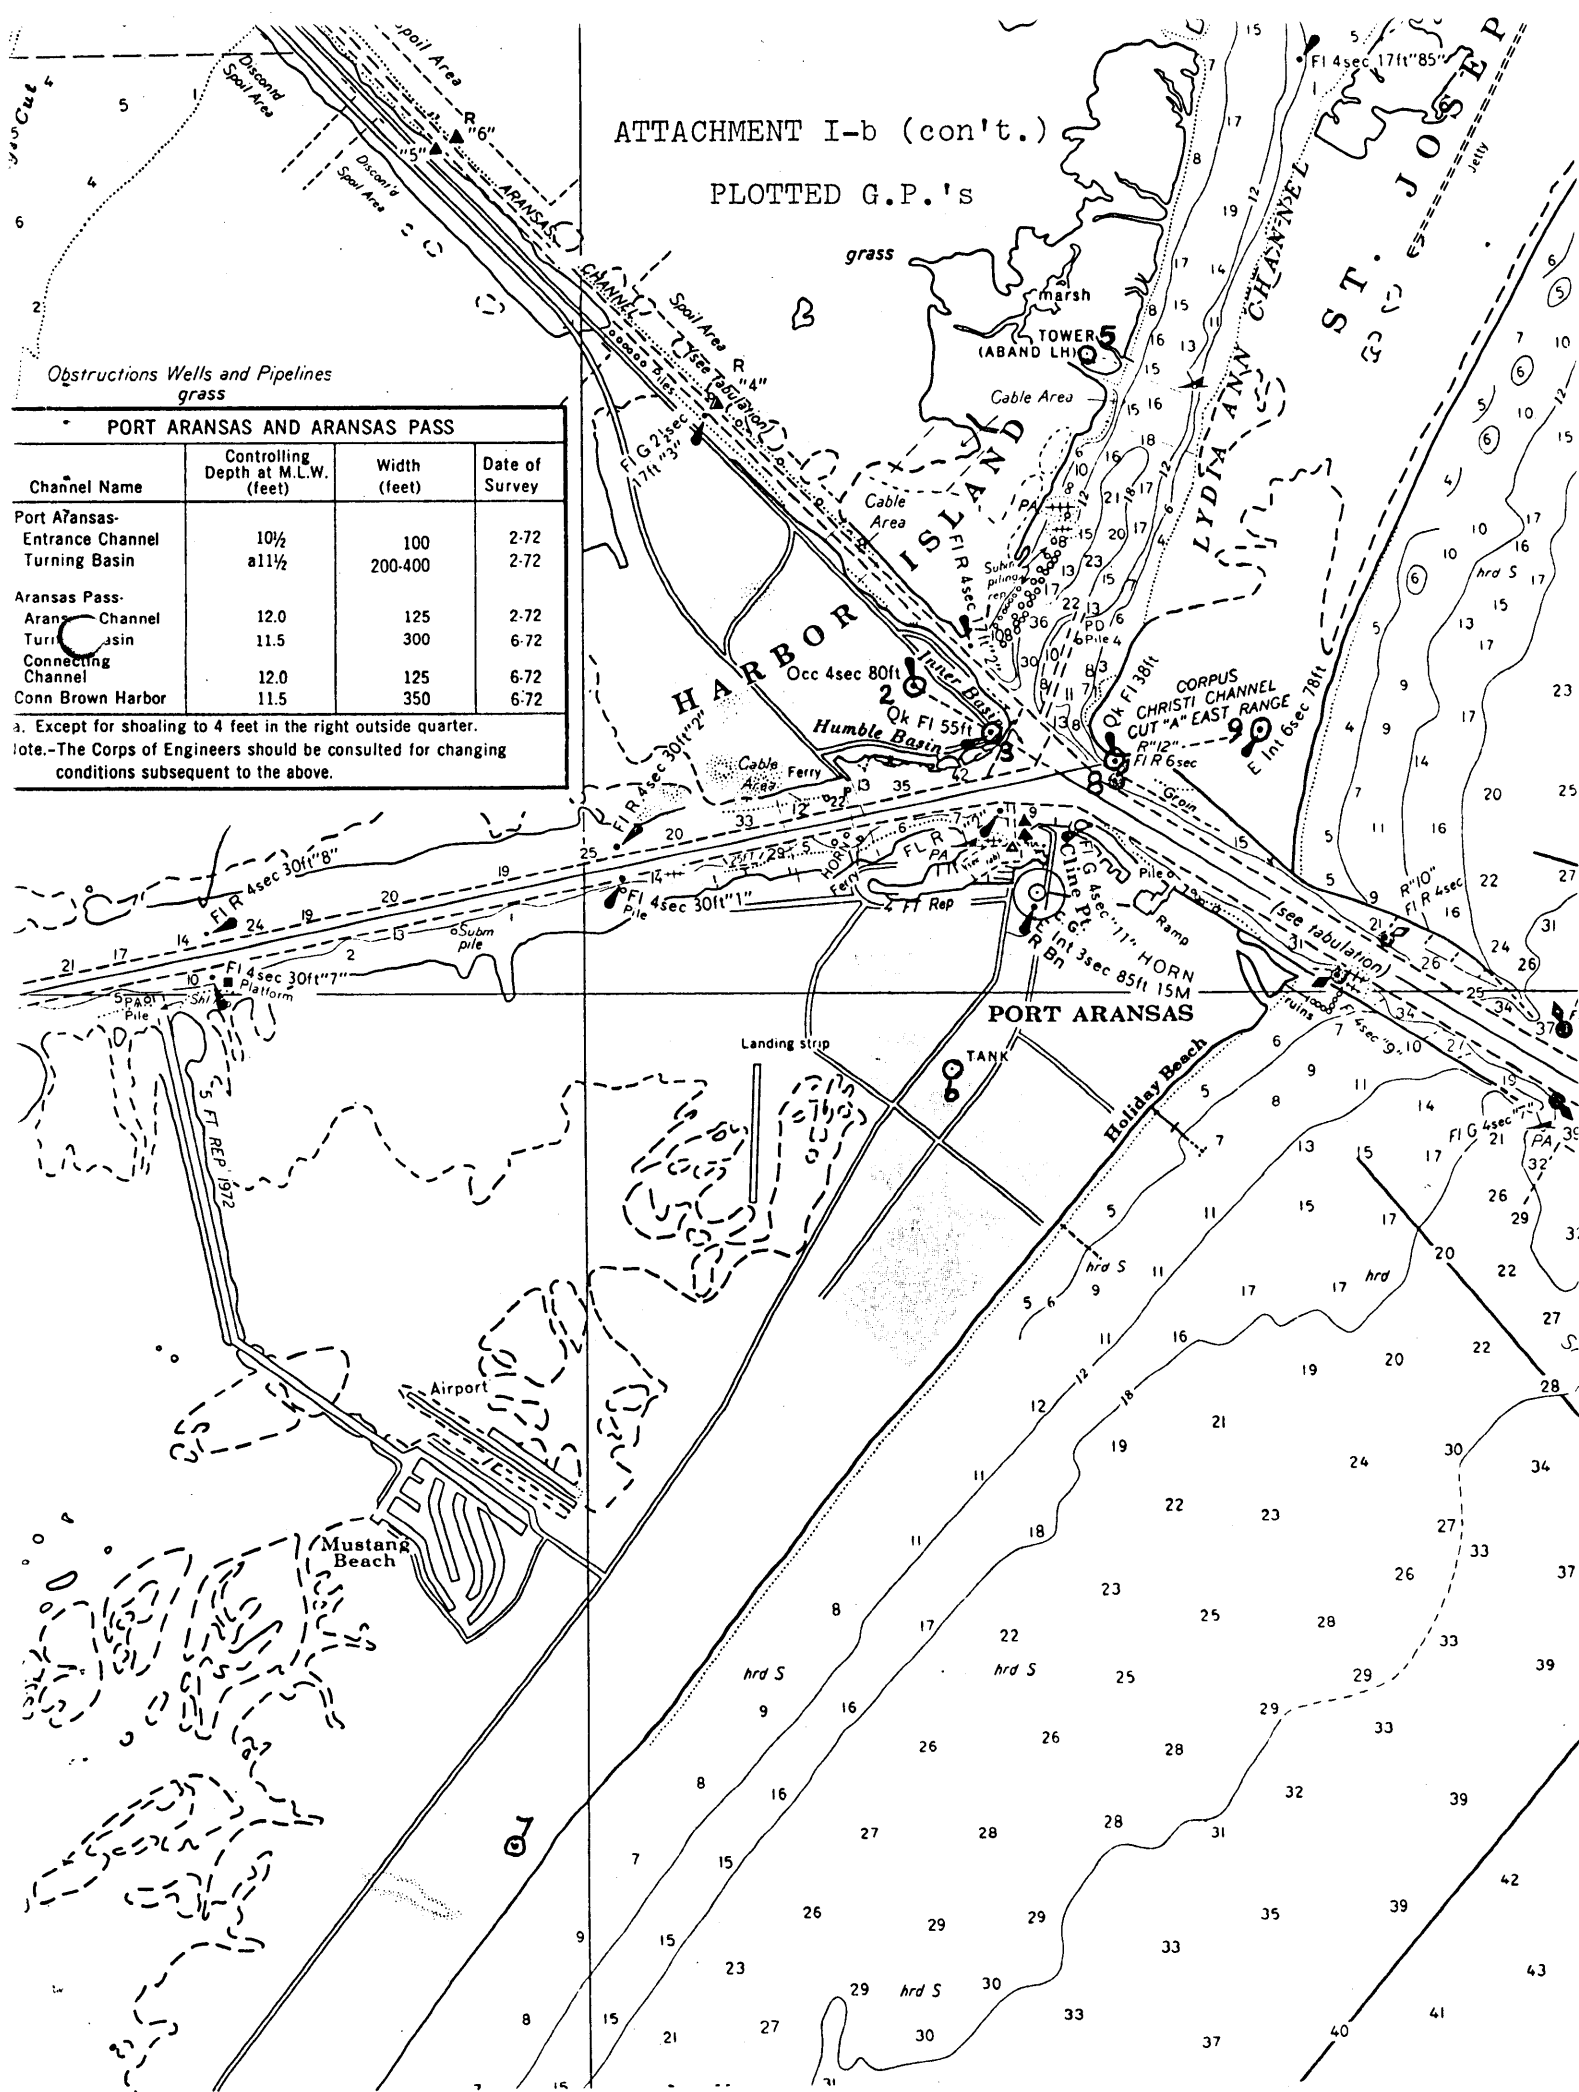
## PLOTTED G.P.'s

POSITION NO. & DAYLETTER	BOUY NO.	LATITUDE	LONGITUDE	GROUNDED		CLEARED		EFFECTIVE		SOUNDING	DEPTH	CHARTED DEPTH	NOTE	REMARKS
				DEPTH	BY DAY	STRIP NO.	NO.	DEPTH	EFFECTIVE					
26A	3-4	27°48.96'	97°00.50'					48				50		Hung buoy R"3" SW-NE.
26B	9-10	24°48.07'	96°59.39'	49		C-2		48						Mud hang.
12D	7-8	27°53.01'	96°56.18'	44		L-1		42		46*		45		Steel object, cylinder 3.5' off bottom.
25D	4-5	27°											1	Hang in spoil area, SW of channel.
28F	7-8	27°47.41'	96°57.16'											Hung Sea Buoy "AP" NE-SW.
38F	7-8	27°46.28'	96°58.28'										2	Fish Haven hung NE-SW.
14G	7-8	27°44.85'	96°59.61'	58		P-4		45.5				48		Oil platform NE-SW.
30G	3-4	27°44.85'	96°59.61'											Oil platform SW-NE.
10H	3-4	27°47.28'	96°57.30'											Hung sea buoy "AP" SW-NE.
10H	4	27°47.30'	96°57.62'	55.5		L-3		53.5		60*		60		Hung old sea buoy 5' off bottom.
9J	5-6	27°48.45'	97°00.28'										1	Hang in spoil area SW of channel.

12J	3-F												1	Hang in spoil area SW of channel.
25L	3-4	27°47.45'	96°57.25'											Hang sea buoy "AP" to clear holiday.
1557-7M	3-4	27°48.64'	97°59.80'										1	Hang in spoil area SW of channel.
1557-16M	3-4	27°48.85'	97°00.10'										1	Hang in spoil area SW of channel.
24M	2-3	27°46.30'	96°58.30'	54.5		P-4		45.5		58*		48	2	Fish Haven hung W-E 3.5' off bottom.
11N	6-7	27°45.20'	96°59.44'	58		N-3		53.5		60*		60		Hung steel tank 4'-5' off bottom.
22N	6-7	27°45.93'	96°58.33'	57.5		P-4		45.5				48	2	Fish Haven hung SW-NE.
5P				52		P-4		45.5				48	2	Fish Haven hung same as 22N.
10P				48		P-4		45.5				48	2	Fish Haven hung same as 22N.
13P	3-4	27°46.48'	96°58.30'	48.5		P-4		45.5		63*		58		Steel object hung 10' off bottom.
10Q	N-1	27°43.10'	96°58.55'	64.5		Not		Not		68*		68		Hang "OLD SHIP" 6' off bottom.

\*Divers measured depth. 1- Mud "aground" hang in Corps of Engineers spoil area, Fish Haven. Fish Haven buoy missing as of 20 September 1973.
